External Corrosion Repair 2" Ground to Air Terminal Pipe

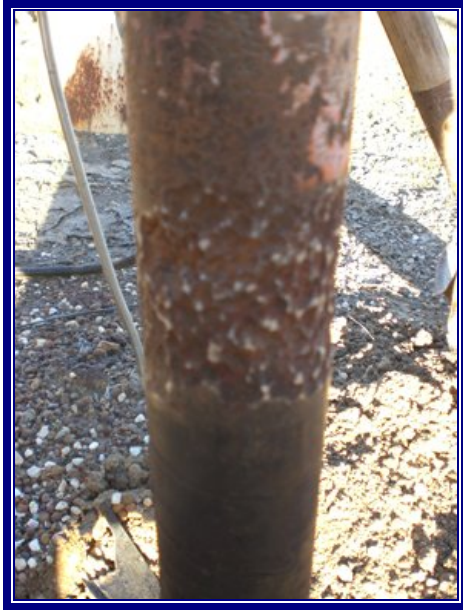
Before; Severe External Corrosion

Situation: A Power Plant in north Houston experienced corrosion at the soil-to-air interface. The terminal piping which supplies natural gas to the Power Plant had multiple locations where piping coming up from the ground pitted and needed to be immediately repaired. Clock Spring® representatives quickly responded that day and determined that Contour was the safest and most suitable repair method for these anomalies.

Solution: A four separate layer Clock Spring Contour system was applied over the anomalies on a series of 4 different terminal pipes. Two Clock Spring representatives conducted the installation and repair. Contact Clock Spring® Co., L.P. for any further questions or details.

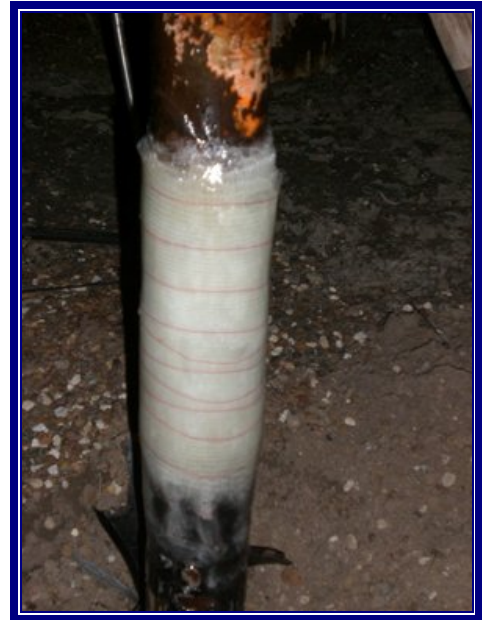
After; Corrosion Contained and Repaired
