# CLOCK SPRING®

## Plant and Refinery Case Studies

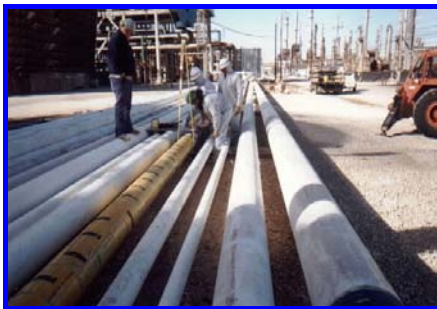
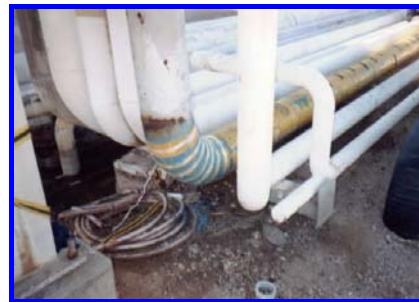
A corrosion cell can find its way to a pipeline not only through the ground, but also by air. Recently, a refinery in southeast Houston, Texas found how corrosive an 'air-borne' drift from a cooling tower can be. An above ground pipeline had corrosion spots spanning over nine hundred feet running parallel to a cooling tower.

903 units were installed at the rate of approximately 75 feet to 100 feet per day. As a cleaning crew prepped the pipe, three installation crews applied the Clock Spring® Snap Wrap kits by hand spool method since the pipes were within three inches of other hazardous product line. The repairs also included 90 and 45-degree fittings.

Clock Spring® not only provided reinforcement to the damaged areas along the pipe, but also permanent protection from suspension chemicals found in the drift of vapor off the cooling towers. The projected life of the repair exceeds the life of the plant.

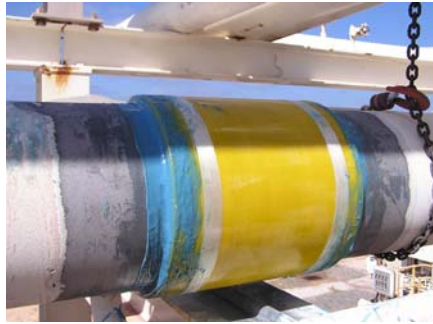
An international gas company has used Clock Spring® within their gas production facility to treat and prevent further corrosion of their pipelines sitting on pipe supports. Clock Spring was used on both low and high-pressure pipelines with corrosion wall loss greater than 30%. The ability to repair without shutdown or welding was of high value to the continued gas production. Their employees are now suitably trained to install Clock Spring as the need arises and will continue to monitor their pipelines for further application and cost savings.

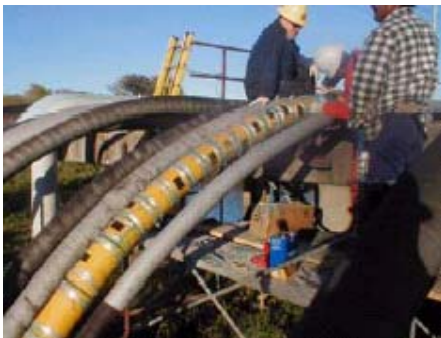
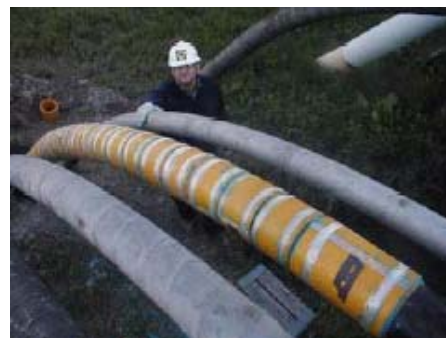
A company in Pasadena, Texas called Clock Spring to assist with a bend repair for a 6-inch pipe carrying ethylene over a small canal. There were additional pipes running parallel about 5 inches apart. At certain times of year, the pipes become completely submerged in water and therefore experience corrosion issues. Corrosion pits were scattered through the tangents into the bend over a 12-foot arc length.

Clock Spring sent technical representatives to complete the repair. Due to the lack of working space, the hand spool method was used to install units. Approximately 18 units were used to cover the 12-foot arc across both sides of the pipe. Some of the units were cut to fit the bend properly. Roughly 36 units all together were installed within 5 hours. A wax tape was used to mold into the gaps and protect the Clock Spring® units from UV intervention.

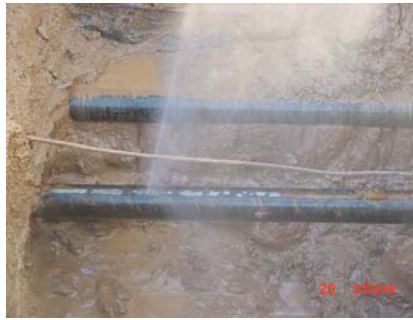
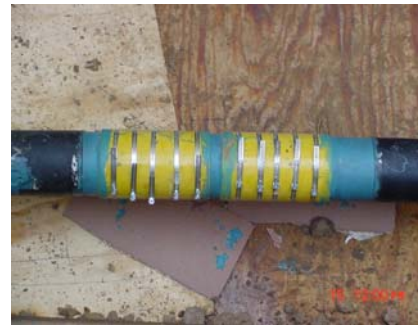
During a scheduled turnaround, multiple through-wall defects were uncovered in a section of process piping. The 8-inch stainless steel schedule 10 pipeline, operating at less than 50 psi, had pinhole defects spanning over 20 feet. A shutdown of a byproducts line out of the unit caused a volumetric increase of corrosive material in the vapor. Corrosive liquids accumulated at elevation changes and fittings across the outlet section.

The product, which operates at less than 100 degrees Fahrenheit, is comprised of 82 percent nitrogen, 6.5 percent acetic acid, 1.9 percent water, 8.3 percent oxygen, 1 percent hydrogen bromide, 0.2 percent methyl acetate and 0.1 percent methanol by volume. Clock Spring Leak Stop-02 repaired over 35 feet of this piping with scattered pinhole leaks. The chemical resistivity was not an issue; the sealing material is inert to most corrosive materials.

Clock Spring can provide data that displays the resistivity of most compounds. The one-man operation took less than two days to complete. Clock Spring not only provided reinforcement to the damaged areas along the pipe, but also permanent protection from any future corrosion. The projected life of the repair exceeds the life of the plant.

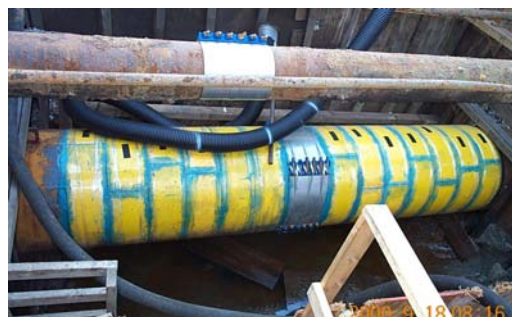
A Clock Spring® customer called for help on an unusual problem. They had a 42-inch diameter, low-pressure, water line that had developed a leak and they could not take the line out of service. After investigating, they found that the line had severe external corrosion along a 12-foot section. They repaired the leak with a compression sleeve but were concerned with the other defects. In fact, as they were cleaning these defects, some of them began to weep slightly.

The customer had used Clock Spring® for high pressure pipeline repairs and called to determine if it could be used for this repair. Clock Spring Company, L.P. designed a Leak Stop repair that not only stopped the leak but also protected the pipe from further corrosion. Thirteen 2-wrap Leak Stop units were installed axially along the damaged pipe. The repair was completed quickly without disrupting flow.

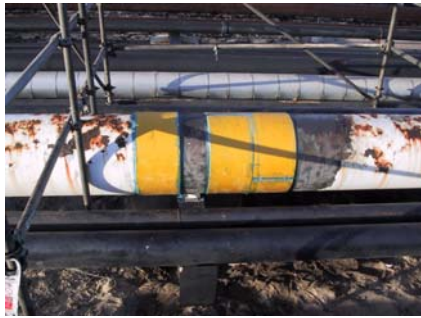
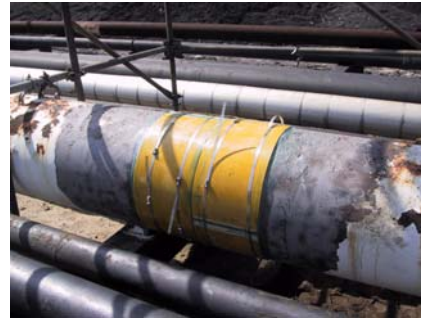
In El Segundo, California a pipeline off loading product from a tanker to a nearby tank farm had weeps and needed to be repaired before the next shipment. An unexpected delivery forced this group into an immediate repair mode. An over-night delivery of seven Clock Spring® Snap Wrap units and Clock Spring® Leak Repair Systems was sent to arrive by 10 a.m. the next morning. The leaks were approximately 1/8" in diameter due to external corrosion. The seven repairs were completed by 2 p.m. that same day and the cargo was off loaded the next day.

This application is a great illustration of a company investigating its options and responding quickly and efficiently to an unexpected change. The LS-02 is an excellent product for this particular repair; a line that has been shutdown with pinholes, not considered a DOT line, operating at low pressure, but a valuable asset to the company. A quick and effective installation of the LS-02 removed installation problems associated with temporary clamps; environmental disclosures for leaking pipelines near water, and the delay of shipments to other terminals.

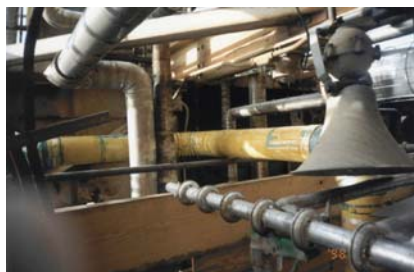
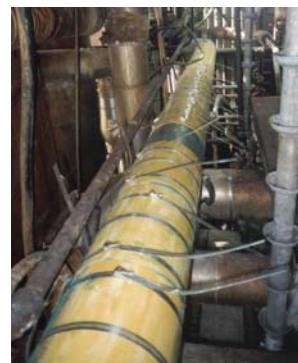
In another recent application, Clock Spring repaired multiple defects, including two leaks, on a high-voltage 6-inch schedule 40-conduit pipe (see figure 2). The 138 kV cable is insulated by pressurized synthetic oil. The pipeline maintains a pressure of 250 psi to insulate the pipe wall from the high-voltage cables. Clock Spring repaired the leaks and almost 15 feet of defects from third-party damage to the pipe wall and coating.

Though the load on the cable was removed, the operator wanted to maintain positive pressure on the line during the repairs. Both leaks were sealed and wrapped with the composite sleeve while the operator maintained 10 psi and 15 psi. The non-leaking defects were repaired with Snap Wrap with normal oil pressure in the pipe (250 psi).

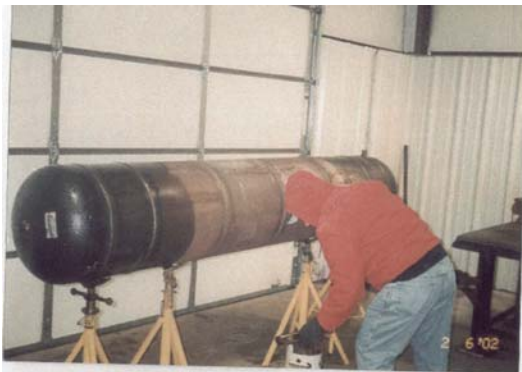
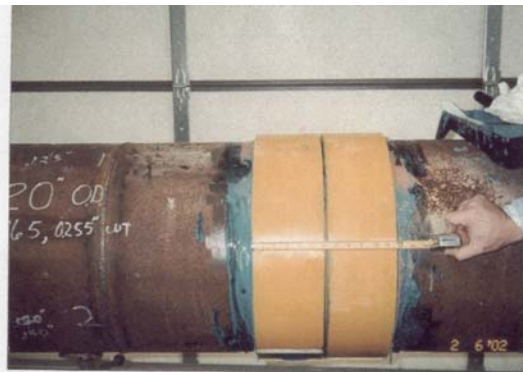
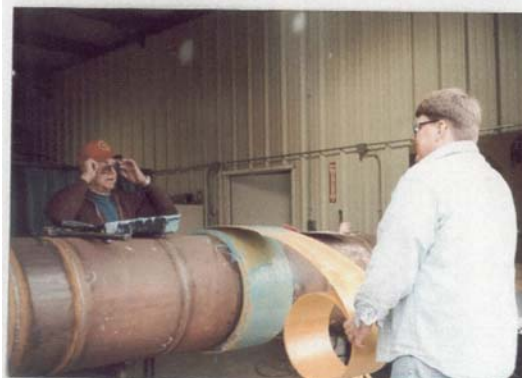
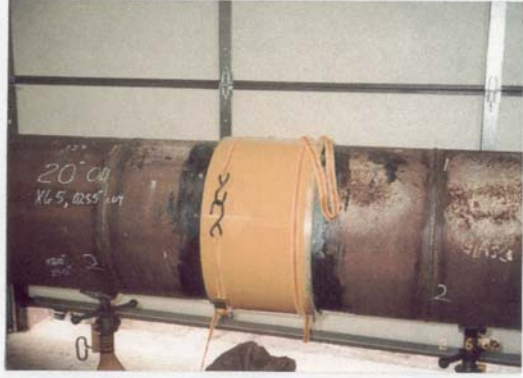
The test spool containing the girth weld defects repaired with Clock Spring® was subjected to hydrostatic pressure until failure occurred.

The failure pressure was 1820 psi, which corresponds to a stress of 72.8 ksi. The failure occurred outside of the repaired area at a small patch of localized corrosion. The failure was a typical "fish mouth" tear, stopping at the installed Clock Spring®.

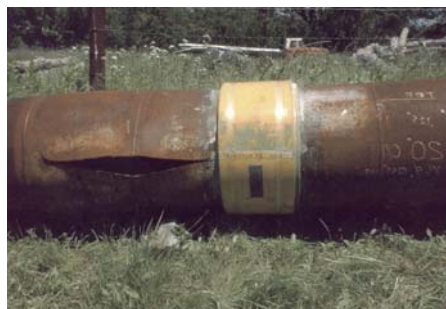
Note the bulging of the pipe outside the repair area.
